RetroFit Parts & Services

Fan Array • EC Motor

Moses H. Cone Memorial Hospital

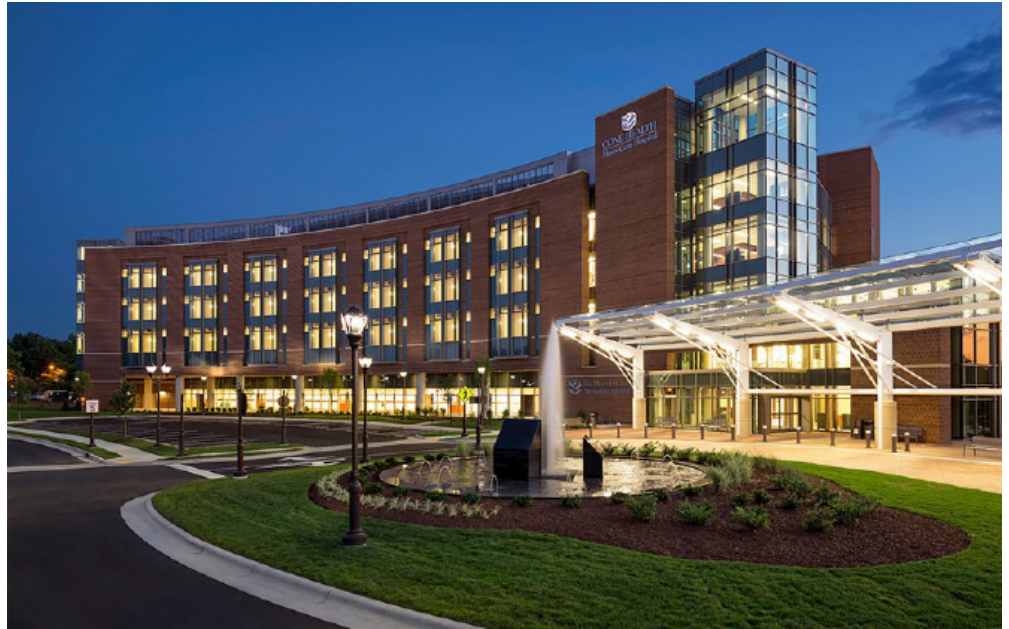
and children's emergency center housing administration offices and regional operations offices, for the Cone Health network. When one of the building's 2 DWDI (double width double inlet) fans serving the building's AHUs began showing signs of serious trouble, the facility's chief engineer reached out to Thermal Resource Sales (TRS) Sales Engineer Rick Cates of NC, who partnered with custom air handling manufacturer TMI Climate Solutions for a prompt solution.

The Hospital needed a quick solution to solve its deteriorating AHU issue. Since just one of the facility's supply fans for the building's AHU had begun to fail they needed a rushed solution before it went out completely. DWDI fans are not built for redundancy so, if the one fan had failed, the load on the remaining fan would've been too great and the facility would have faced an unbearable winter. In addition to reliable fans with redundancy protection for future maintenance and service; other replacement fan requirements included: Expedited delivery, modularity to easily fit in small footprint, high reliability of at least 38,000 CFM (total) at 4 inches of static pressure per fan replacement. Another critical requirement was quick and easy installation due to one already worsening DWDI fan.

To meet the client’s capacity and energy requirements, as well as provide redundancy, TMI Climate Solutions supplied 2 Custom EC Motor Fan Arrays, manufactured in Galvanized Steel with Acoustic lining for optimal performance and unit efficiency.

To reduce sound levels and provide redundancy protection when fan maintenance is required, multiple fans were stacked in an Array. The arrays were built with an arrangement of 6 fans stacked 2 high and 3 wide and were designed to replace the operating DWDI fans inside the existing AHUs. Each Array would provide 35,800 CFM at 4 inches of static pressure, which satisfied the total 65,200 CFM requirement.
