## RetroFit Parts & Services

Fan Array • EC Motor

Moses H. Cone Memorial Hospital

# Project Highlights

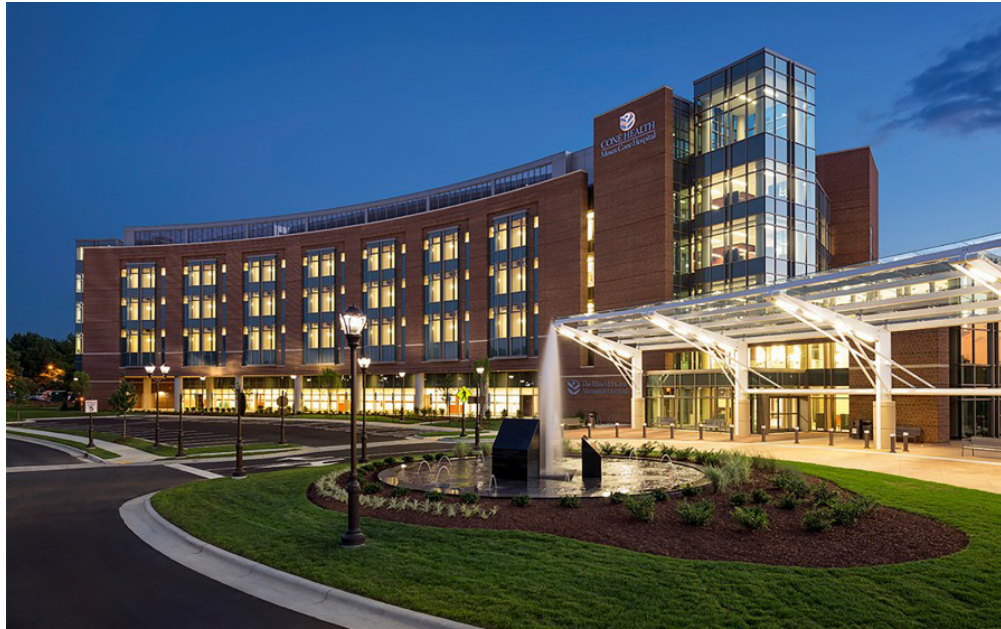
and children's emergency center housing administration offices and regional operations offices, for the Cone Health network. When one of the building's 2 DWDI (double width double inlet) fans serving the building's AHUs began showing signs of serious trouble, the facility's chief engineer reached out to Thermal Resource Sales (TRS) Sales Engineer Rick Cates of NC, who partnered with custom air handling manufacturer TMI Climate Solutions for a prompt solution.

To meet the client's capacity and energy requirements, as well as provide redundancy, TMI Climate Solutions supplied 2 Custom EC Motor Fan Arrays, manufactured in Galvanized Steel with Acoustic lining for optimal performance and unit efficiency.

To reduce sound levels and provide redundancy protection when fan maintenance is required, multiple fans were stacked in an Array. The arrays were built with an arrangement of 6 fans stacked 2 high and 3 wide and were designed to replace the operating DWDI fans inside the existing AHUs. Each Array would provide 35,800 CFM at 4 inches of static pressure, which satisfied the total 65,200 CFM requirement.

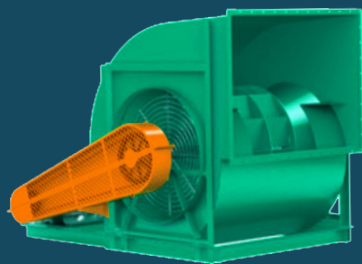
**DWDI Fans are not built for redundancy where as TMI's Fan Array Solutions provide you with easy service access and protect you in the event of future maintenance issues.**

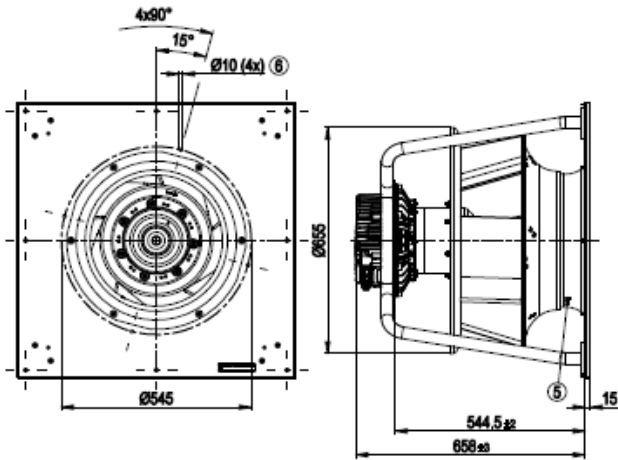
Ideal operating range per EC Fan
