RetroFit Parts & Services

Fan Array • EC Motor Moses H. Cone Memorial Hospital

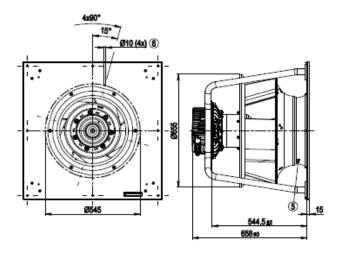
DWDI Fans are not built for redundancy where as TMI's Fan Array Solutions provide you with easy service access and protect you in the event of future maintenance issues.

Ideal operating range per EC Fan

To reduce sound levels and provide redundancy protection when fan maintenance is required, multiple fans were stacked in an Array. The arrays were built with an arrangement of 6 fans stacked 2 high and 3 wide and were designed to replace the operating DWDI fans inside the existing AHUs. Each Array would provide 35,800 CFM at 4 inches of static pressure, which satisfied the total 65,200 CFM requirement.
